Analytical Research of the Container Ships Cargo Area Fires in the Period From 2010 to 2020

Ivica Krmek

DOI 10.17818/NM/2022/1.8 UDK 629.544:614.84 Review / *Pregledni rad* Paper received / *Rukopis primljen*: 13. 4. 2021. Paper accepted / *Rukopis prihvaćen*: 26. 11. 2021.

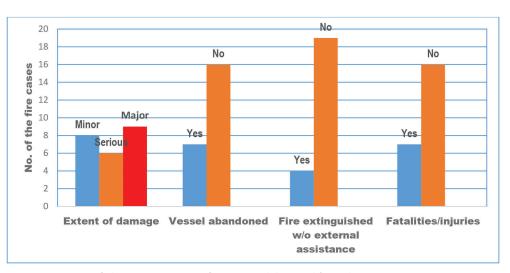
Figure 4 Firefighting operations efficiency as elaborated from the investigation reports Slika 4. Učinkovitost vatrogasnih operacija obrađenih iz istražnih izvješća

Figure 4 shows the overall efficiency of the fire extinguishing operation. The following four elements were analysed: the extent of damage, whether the ship was abandoned after the fire broke out due to the sudden escalation of fire and danger to human lives, whether the fire was extinguished by the crew or by external assistance (firefighting personnel, tugs, salvage teams, helicopters, etc.), and whether there were any deaths or injuries during firefighting operations.

The extent of damage to the ship and cargo is classified into three categories: minor, severe, and major. The number of damaged containers and the severity of structural damage to the ship was taken as the criteria for determining the degree of total damage caused by the fire. Damages up to 10 containers and damages to the ship's structure that can be repaired within one week are classified as minor. Damages from 10 to 100 containers and damages to the ship's structure requiring repair from one week to one month are classified as serious, while all damages requiring repair for a period longer than one month and if the number of damaged containers exceeds 100 are classified as major.

The ship was abandoned due to the sudden escalation of fire and danger to human lives in cases 1, 2, 4, 6, 17, 18 and 19.

The fire was extinguished by the crew without external assistance only in cases 3, 13, 21 and 23. In the cases where the fire was extinguished with external assistance, various resources were used, such as firefighting tugs, firefighters, firefighting planes, rescue vessels and helicopters, coastguard vessels, towing tugs, and salvage teams. The resources used in these cases range from one firefighting tug and firefighting team (case 5) to several firefighting tugs with firefighting teams, helicopters, two salvage companies and towing tugs (case 18).

Cases 1, 2, 15, 16, 18, 20 and 22 resulted in either dead or injured personnel. In case 2 there were 3 dead and 2 seriously injured crew members. Case 18, fire on MV Maersk Honam was one of the most devastating fires on container vessels up to date as it resulted in the loss of 5 crew members' lives and 22 crew members treated in the hospital. In case 22 more than 200 people were treated in the hospital due to respiratory problems. Injuries in cases 1, 15, 16 and 20 were limited to 1 to 3 persons who suffered burns and respiratory problems.
